Arbour Report and outline development plan – April 2021

Farnhill Parish Council had an informal socially distanced meeting at the Arbour on Saturday 10th April to discuss a plan for the future maintenance and works at the Arbour.

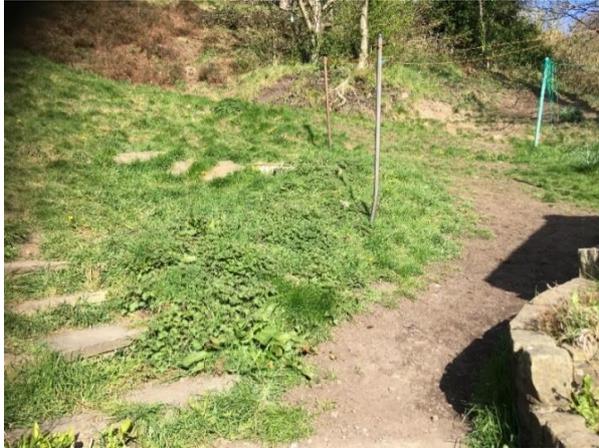
Photo 1.

- Construct a path to follow the line of the “dirt” path from the top of the steps leading into the north of the Arbour from Main street to the recently re-laid path which leads from the bottom right of the Arbour to the top left by the seat and viewing area. [see photo 1]
- Take out the remains of the old stone steps at the bottom of Lower Arbour [the large stones piled in the grass in the centre of photo 1] and re-set them on this new path to form steps as necessary.
- If further steps are required new stone will be acquired to complete the job.
- Make good the ground where the stones have been removed and re-seed.
- This path should be Part M Building regulation compliant.
- The stones forming the steps to the left of the picture to be cleared of vegetation and made good as necessary. [see also photo 2 below]

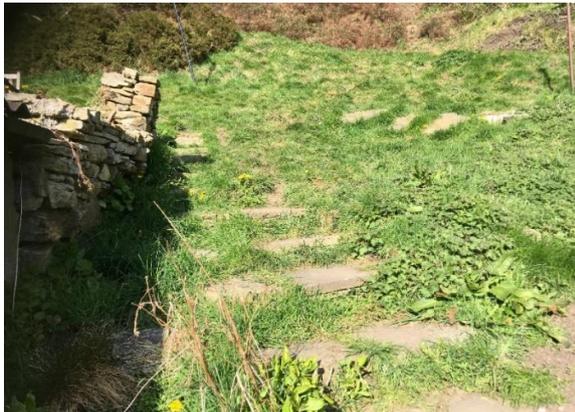
Photo 2

Steps will lead from the path onto the footpath running right to left in the top quartile of the photo.

The path will consist of:

1. gently inclined turf within a plastic grid *
2. gently inclined plastic grids infilled with river gravel *

to ensure firm safe footing {fixed according to the manufacturer’s specification edged as necessary and appropriate using manufacturer’s edging]

Steps will be sited where necessary to enable the gradient to remain gentle and fall within the regulatory requirements of public pathways.

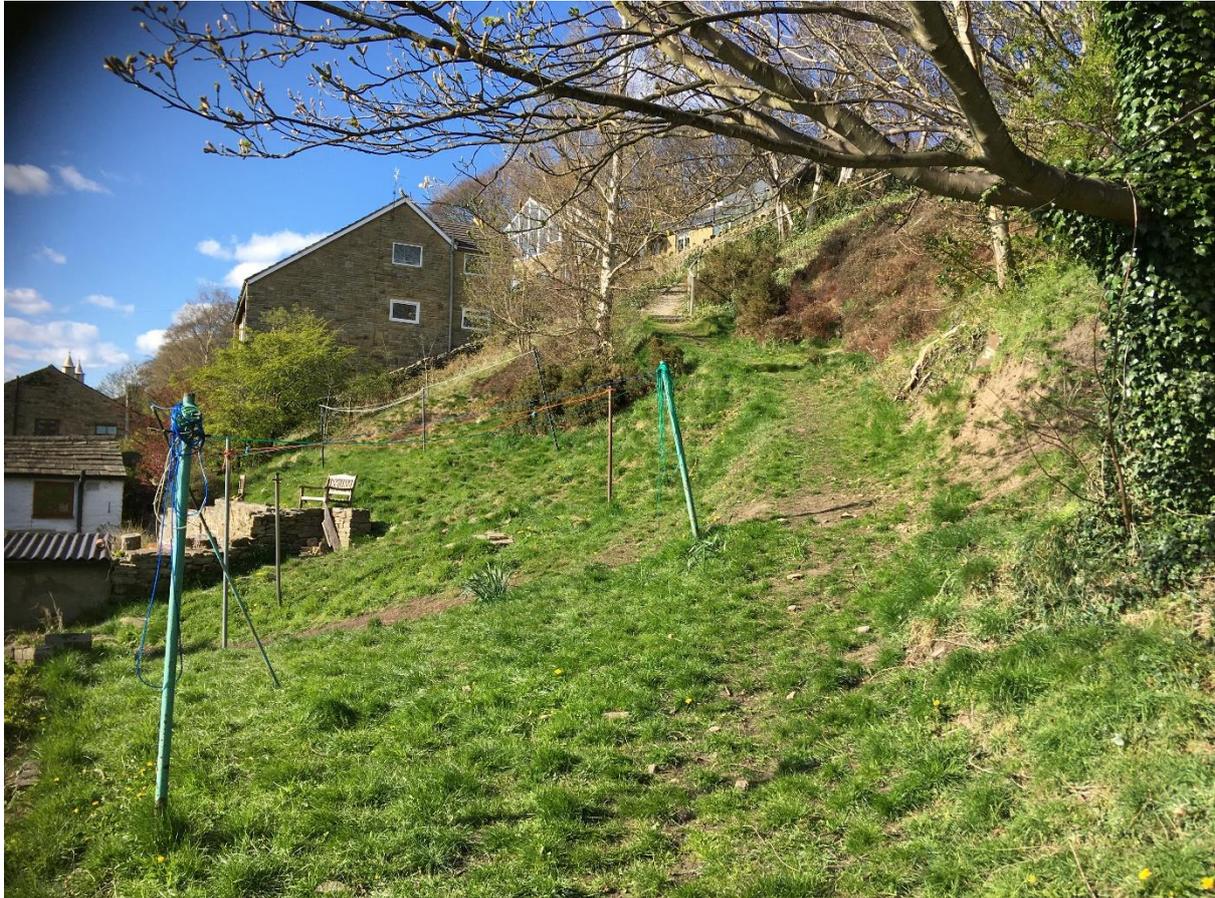
Photo 3

The path running from centre bottom of the photo to the first visible stone step will be regraded to lessen the gradient and to be Part M Building Regulation compliant

Wooden steps will be created as necessary to ensure a gentle gradient.

The surface will be reset with plastic path grids filled with earth and seeded, or filled with river gravel in accordance with the manufacturer's specification, to ensure a solid gripping surface and edged with manufacturer's edging as necessary and appropriate.

Steps will join the path from the left to provide access to the path from the northern entrance to the Arbour from Main street

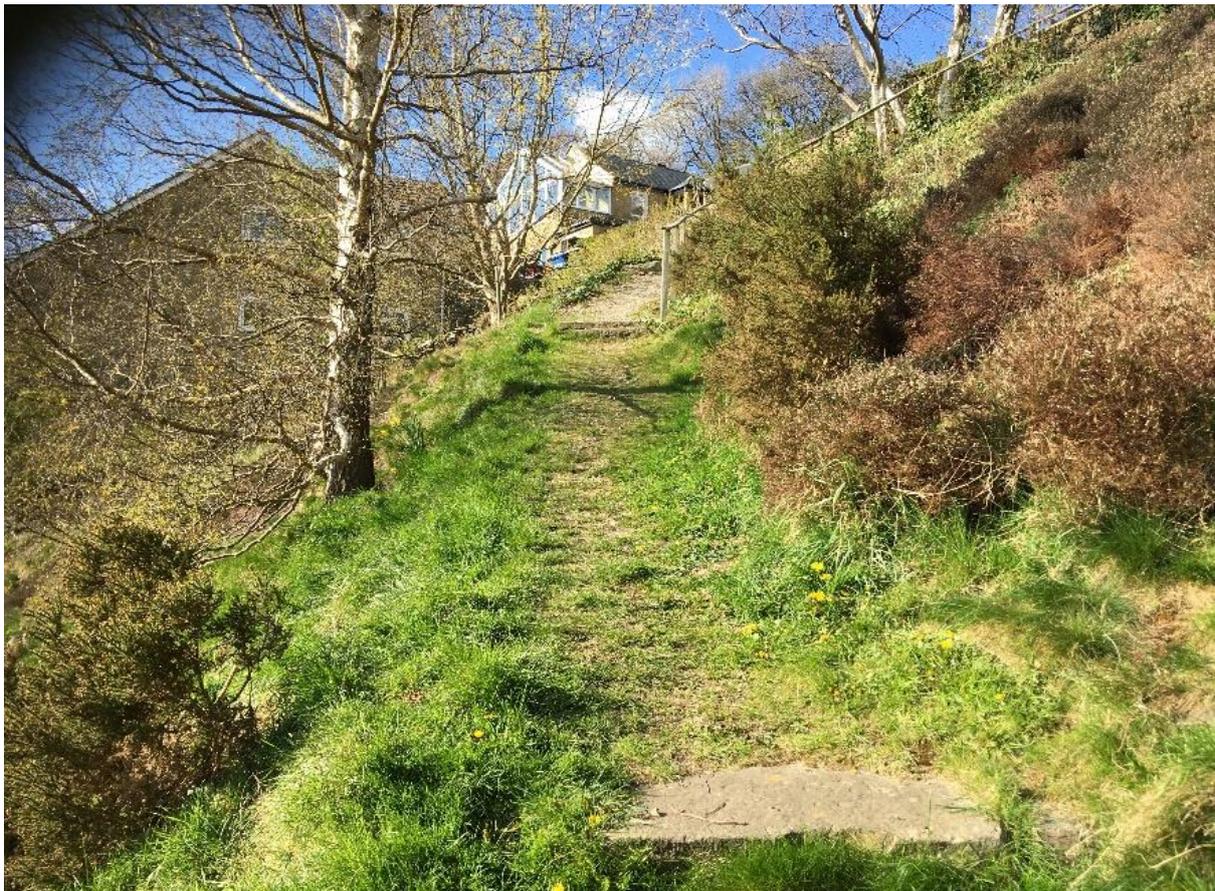
Photo 4

Starting from where the recently re-laid path ends [see photo 4]

- remove the limestone right up to the seat and viewing area.
- lay a base layer and then plastic grids infilled with earth and grass seed or river gravel according to the grid manufacturer's specifications,
- introduce more steps [wooden - with the possible exception of the corner] appropriately spaced to reduce the incline in line with regulations governing public paths. Ensure Part M building regulation compliance.
- remove the handrail and replace with one of reduced height [to meet the standards for public handrails] and splinter free material.
- extend the handrail up to the top corner by the seating area. [see photo5]

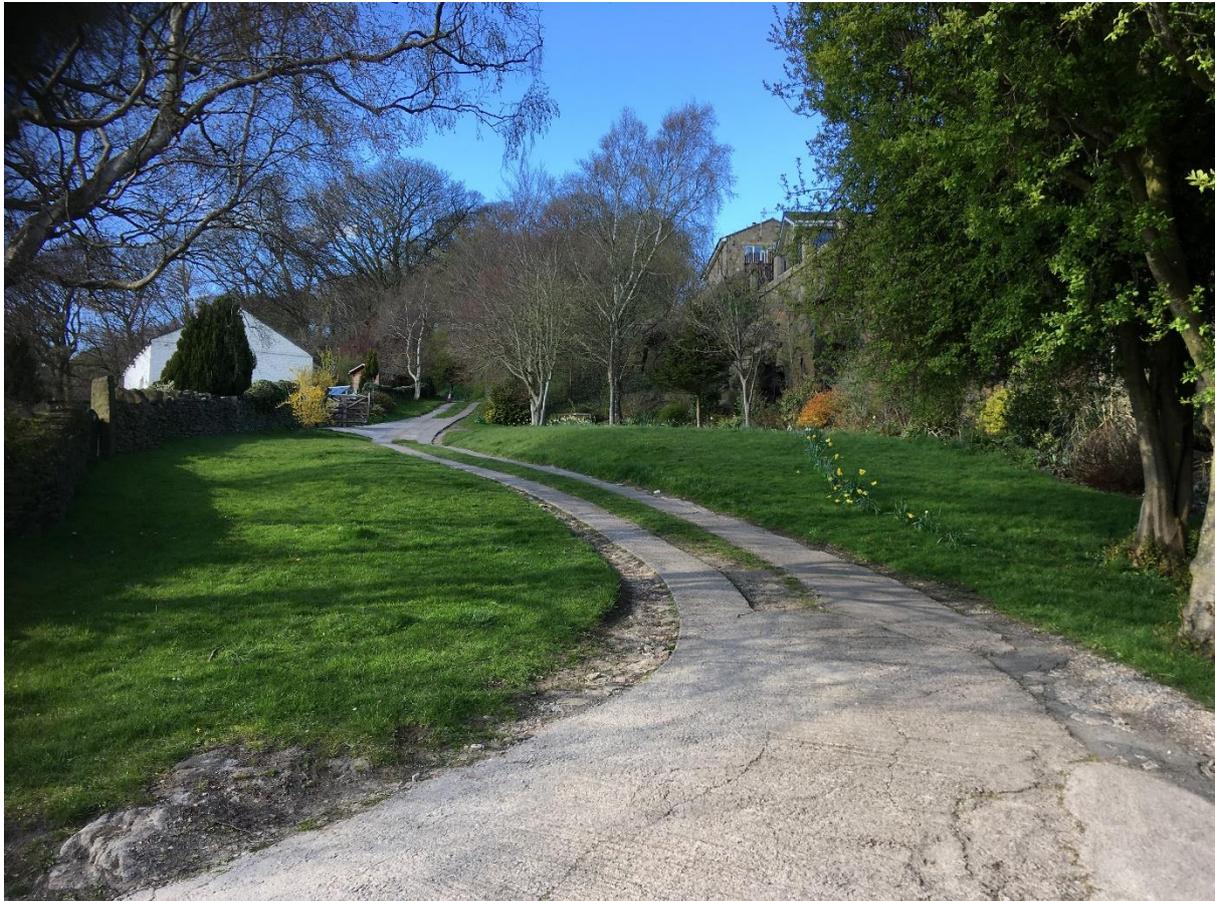
The Parish Council are aware that the road & footpath up to Arbour Top has recently been damaged and has deteriorated and they will continue to monitor it so it does not become a health & safety hazard.

Some years ago, when Crag house was being converted from a bungalow into two-storey house the contractor's vehicles damaged the edges of the concrete road strips. an agreement was reached to repair the strips but was never acted on, there being some discussion about the ownership of the concrete strips and therefore a contribution to the overall costs.

The road and path currently allow for safe access for both pedestrians using the path and resident's vehicles accessing resident's properties.

The council will monitor the situation.

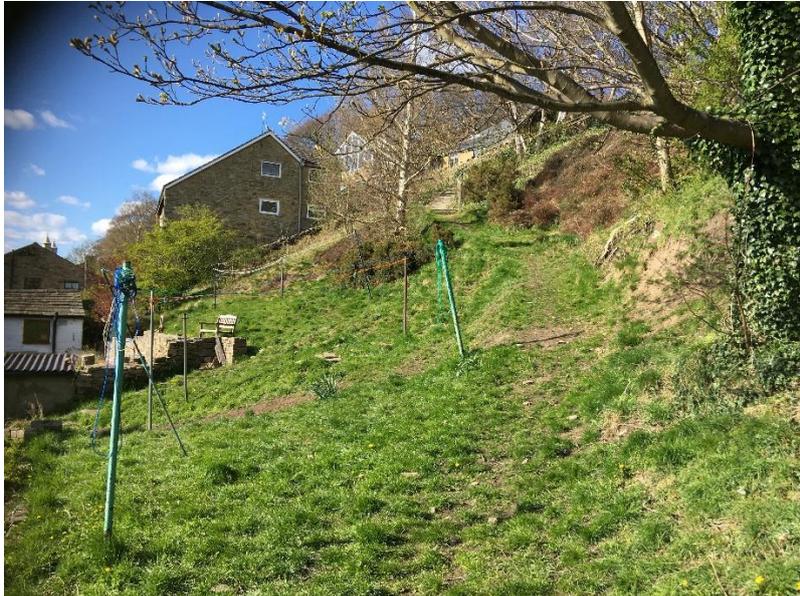
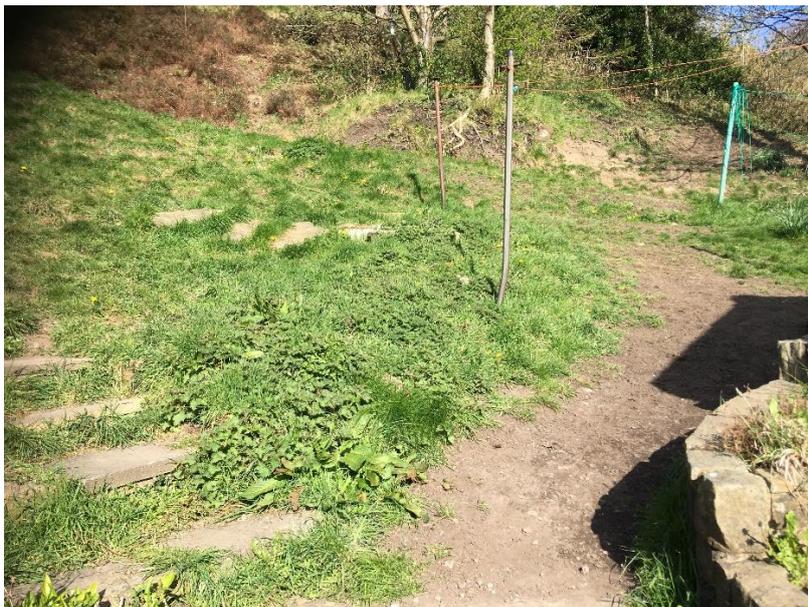
The Parish Council are of the opinion that if the steps at the bottom are re-set to join the path, then some of the washing lines would become a hazard and either the washing lines would have to be taken down or the Parish Council would provide 3 rotary lines in their place.

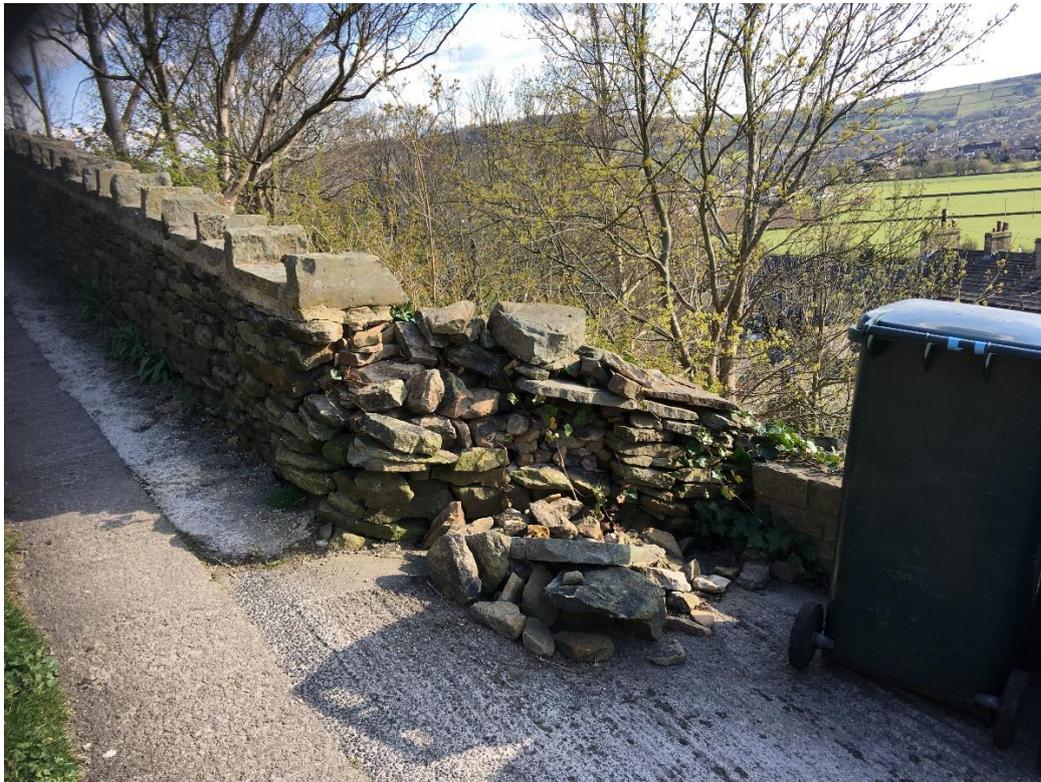
One further item was discovered whilst these photos were being shot which will need addressing. This is the damage to the recently repaired stone wall at the top left of the lower arbour next to the roadway. Here the wall has collapsed or been knocked down.
