Arbour Report and outline development plan – April 2021

Farnhill Parish Council had an informal socially distanced meeting at the Arbour on Saturday 10th April to discuss a plan for the future maintenance and works at the Arbour.

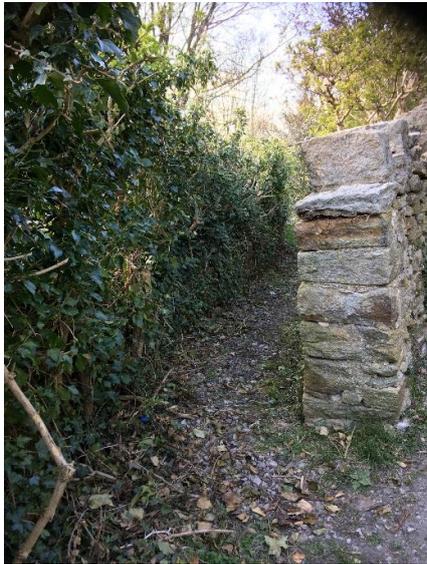
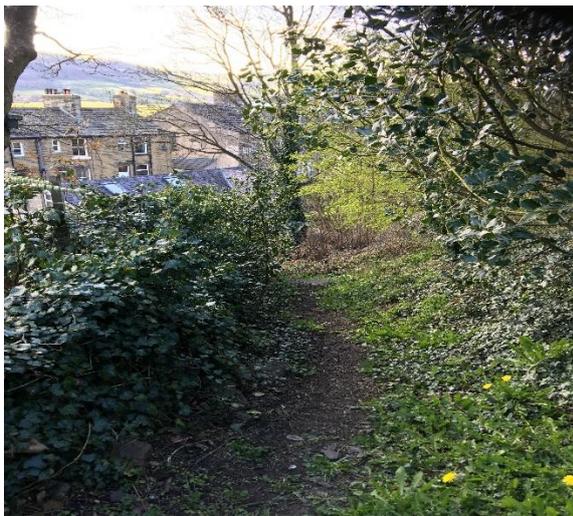
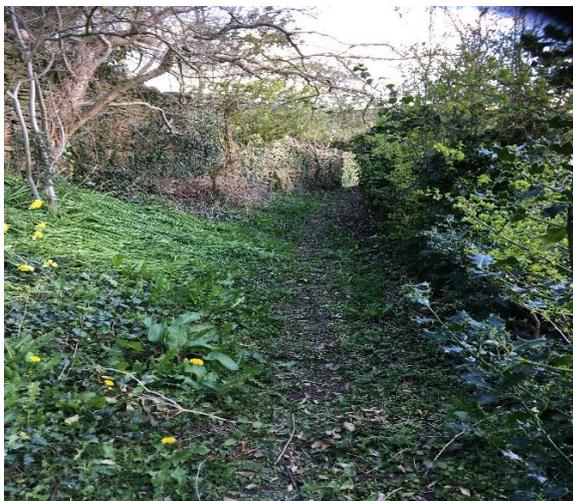
The Parish Council are aware that the road & footpath up to Arbour Top has recently been damaged and has deteriorated and they will continue to monitor it so it does not become a health & safety hazard.

Some years ago, when Crag house was being converted from a bungalow into two-storey house the contractor's vehicles damaged the edges of the concrete road strips. an agreement was reached to repair the strips but was never acted on, there being some discussion about the ownership of the concrete strips and therefore a contribution to the overall costs.

The council will monitor the situation.

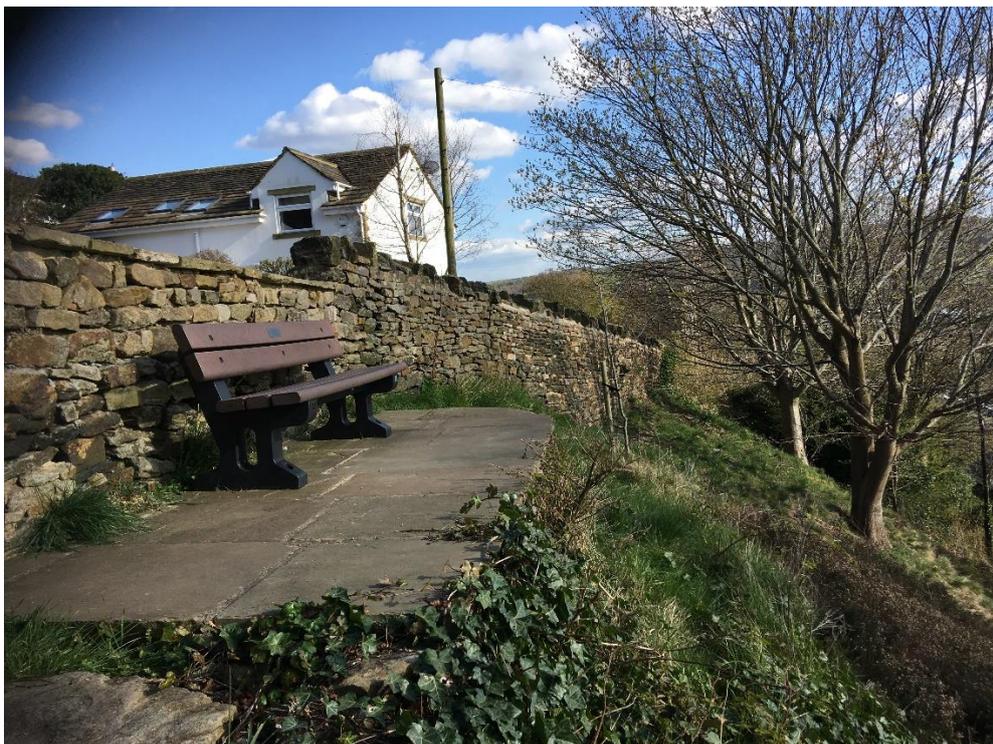
And finally, a photo showing the recently constructed viewing area and seat at the top of lower Arbour with the reconstructed stone wall which forms the boundary between the Lower Arbour and the footpath leading back down to Hanover Street and Main Street
